Experimental dynamic analysis of the arch road bridge

Tomáš Plachý¹, Michal Polák¹, Pavel Ryjáček¹, Milan Talich², Jan Havrlant², Filip Antoš², Jiří Litoš¹, Martin Macho¹, Lubomír Soukup²

Abstract. The paper presents an experimental dynamic analysis of the existing road bridge across the Labe river at Valy village in the Czech Republic. The observed structure is a bridge with 6 spans 23.1 m, 31.5 m, 84.0 m, 31.5 m and 23.1 m long. The horizontal load-bearing structure is a composite structure with two main steel girders and a lower reinforced concrete deck. The load-bearing structure is reinforced in the main span by the arch, this structural system is also called the Langer beam. The experiment was realized in three stages. The first one was performed in May 2020 before its opening, the second stage of the described experiment was realized in August 2020 and the third one was carried out in April 2021. The main purpose of the first stage was to determine in detail the natural frequencies and mode shapes of the whole bridge horizontal load-bearing structure also including the arch. The electrodynamic shaker, that was located on the bridge deck in the quarter of the main bridge sp

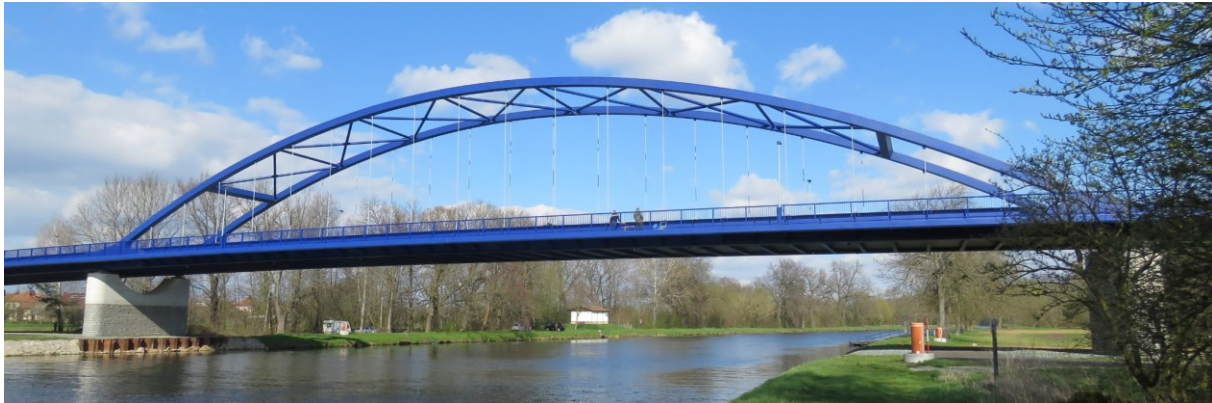
Figure 1. The view on the third span of the bridge where the structure is reinforced by the arch.

The experimental dynamic analysis described in this paper was realized on the existing road bridge across the Labe River at Valy village in the Czech Republic that was put into operation in June 2020 (see figure 1).

The observed structure is the bridge with six spans 23.1 m, 31.5 m, 84.0 m, 31.5 m and 23.1 m long. The horizontal load-bearing structure is reinforced in the main span by the arch, this structural system is also called the Langer beam (see figure 1).

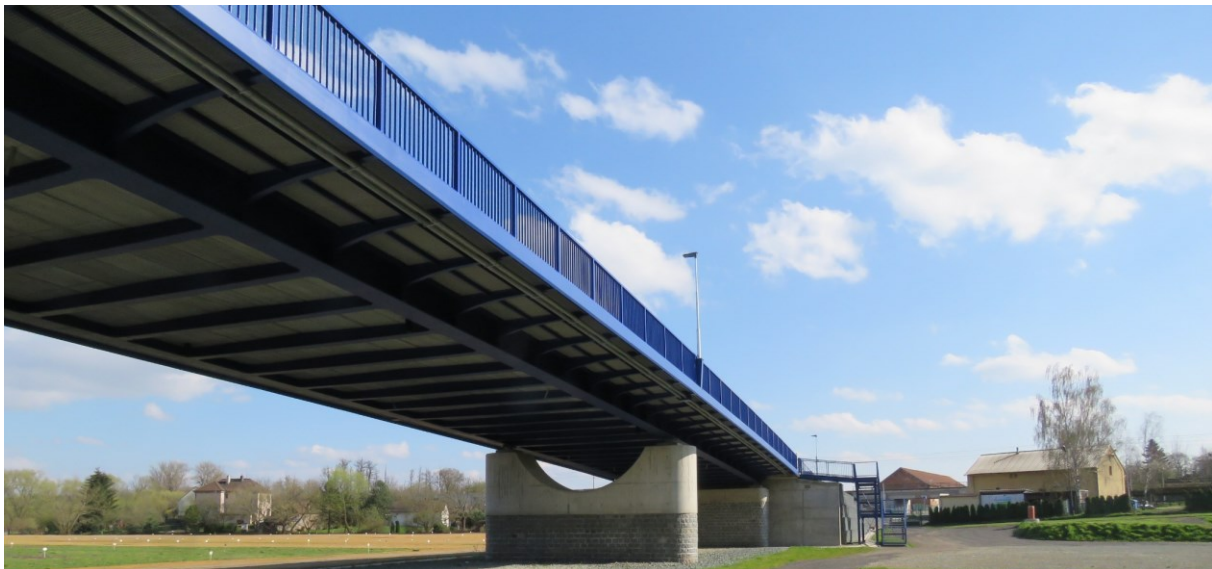
Figure 2. The bottom view on the load bearing structure in the second and first span of the bridge.

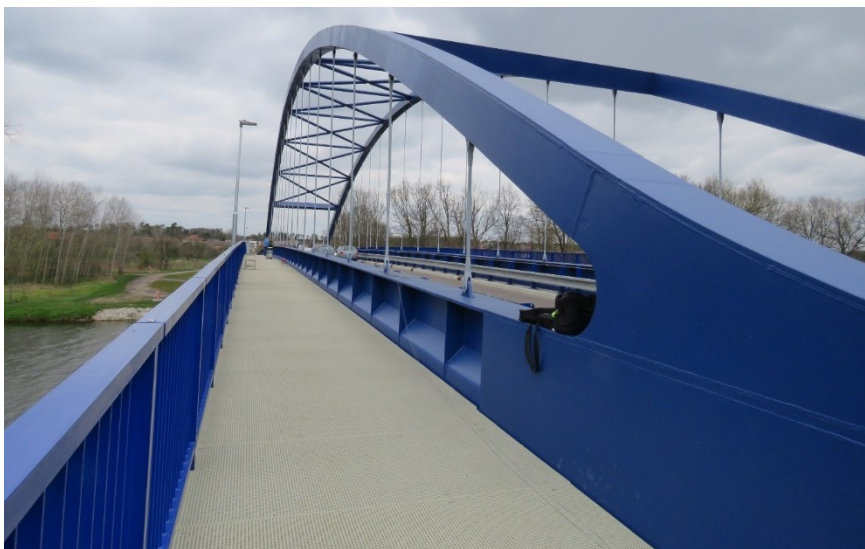
Figure 3. The view on the load bearing structure in the third span of the bridge.

The typical cross section of the horizontal load-bearing structure of the bridge is a composite structure that consists of two identical main steel I shaped girders and a lower reinforced concrete deck (see figure 2). The lost formwork made from ultra-high performance concrete (UHPC) was used for the deck concreting. The steel cross girders are coupled with the concrete deck using the coupling pins. The main girders have constant height 1.80 m and the width of their lower and upper flange is 600 mm. The middle part of the main girders on their both sides is covered by the 8 mm thick steel protective shroud (see figure 3). The concrete deck thickness including the lost formwork is 250 mm. The road width between crash barriers is 6.50 m. Bridge walkways are located on cantilevers outside the main girders and their width is 2.50 m (see figure 3). The total width of the whole bridge cross section is 13.90 m.

The dimensions 600 mm x 600 mm of the welded square box cross section of the arch are uniform along whole arch span except the short part in the connection to the girder on arch ends (see figure 3). The steel bar-type arch hangers (see figure 1 and 3) are made of S460. The main girders, cross girders and the arches are made of S355.

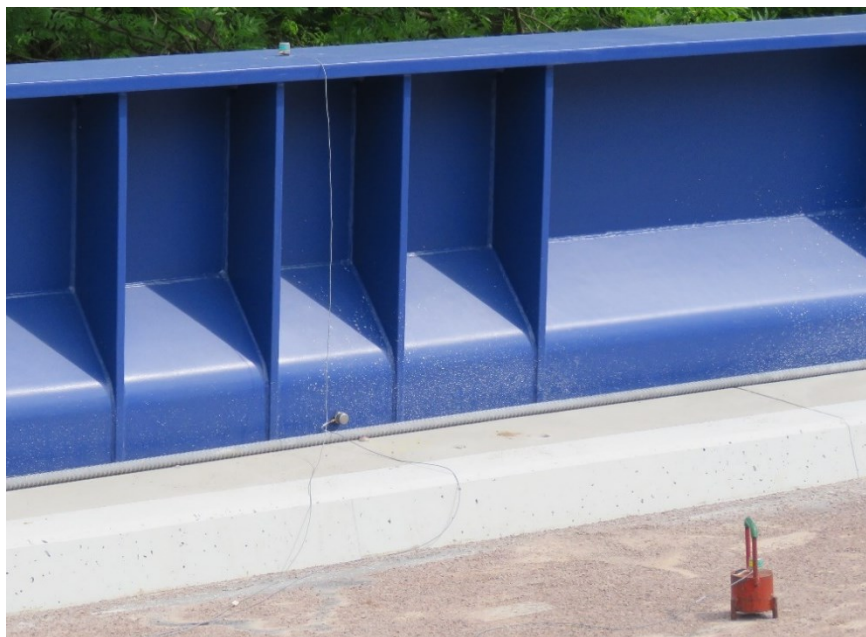
Figure 4. The view on the three accelerometers of type 8344 placed on the main girder and on the roadway.

In the course of the first experiment stage the bridge vibration was measured by eight piezoelectric acceleration transducers Brüel & Kjær Type 8344 (see figure 4). The working range of these sensors is from 0.2 Hz to 3 kHz. These transducers are very suitable for the dynamic experiments realized on bridges because the lower frequency limit of their working frequency range is low enough and they have very high sensitivity of approximately 2500 mV/g.

The response acceleration transducers were attached with neodymium magnets to steel weights, which were moved to the monitored points of the bridge deck (see figure 4). On the main girders, the transducers were attached directly to the steel girders using neodymium magnets (see figure 4).

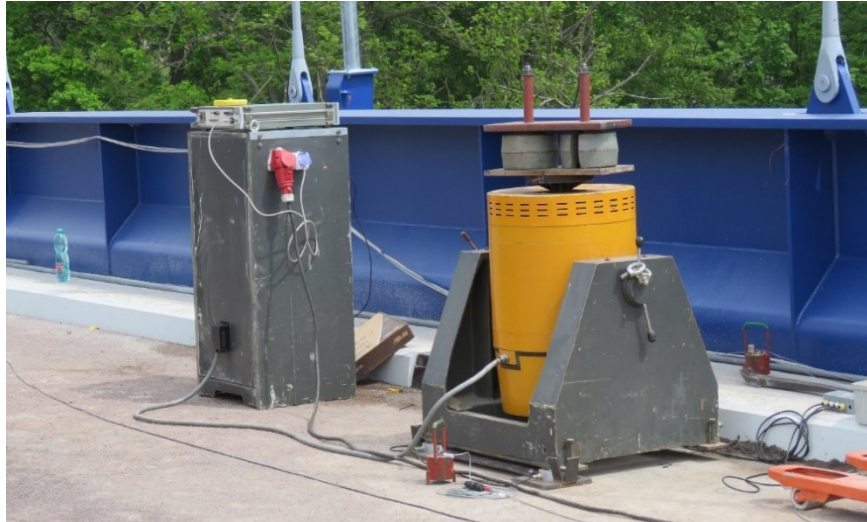
Figure 5. The view on the electrodynamic shaker TIRAVIB 5140 situated on the bridge deck.

The electrodynamic shaker TIRAVIB 5140 was used for excitation of vibration of the observed bridge in the course of the first stage of the experiment. The shaker was situated on the deck eccentrically to the longitudinal axis of the bridge in the third quarter (section No. 16) of the main bridge span that is the 3rd one (see figure 5). The shaker position was selected as its best location on the deck based on the form of the first ten fundamental theoretical natural mode shape of vibration because of the most of them had some sufficiently high ordinate in this point to excite them. During the measurements, the vibration of the exciter weight was controlled to produce an excitation force of a random character.

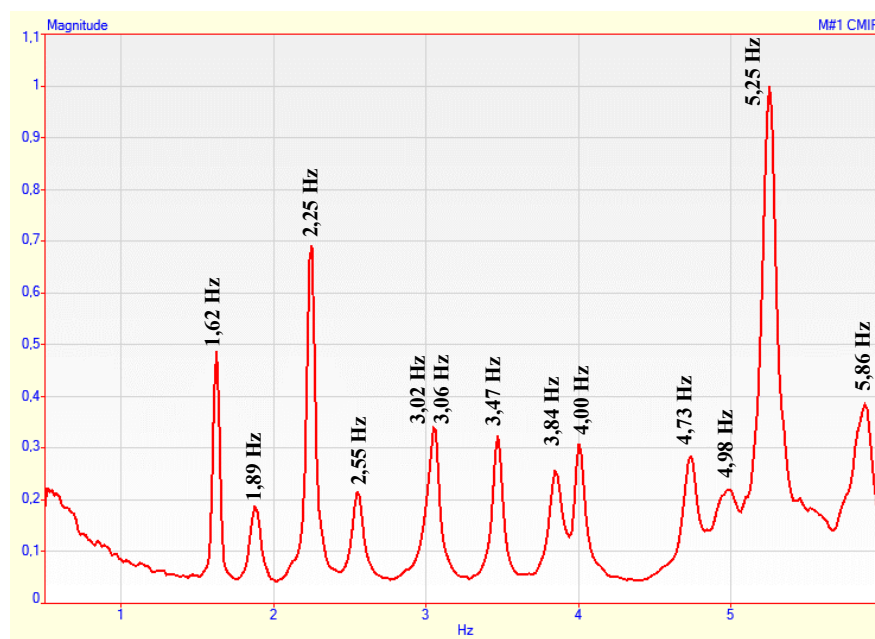
Figure 6. Evaluated Complex Mode Indicator Function (CMIF) with marked identified natural frequencies of the observed bridge.

The natural frequencies were evaluated from Complex Mode Indicator Function (CMIF), which is defined as the eigen values solved from the normal matrix, which is formed from frequency response function (FRF) matrix. CMIF can be computed from multiplication of normal matrix with its Hermitian matrix or by singular value decomposition (SVD) of normal matrix at each spectral line [12], [13]. The first ten natural frequencies (see table 1 and figure 6) and corresponding mode shapes

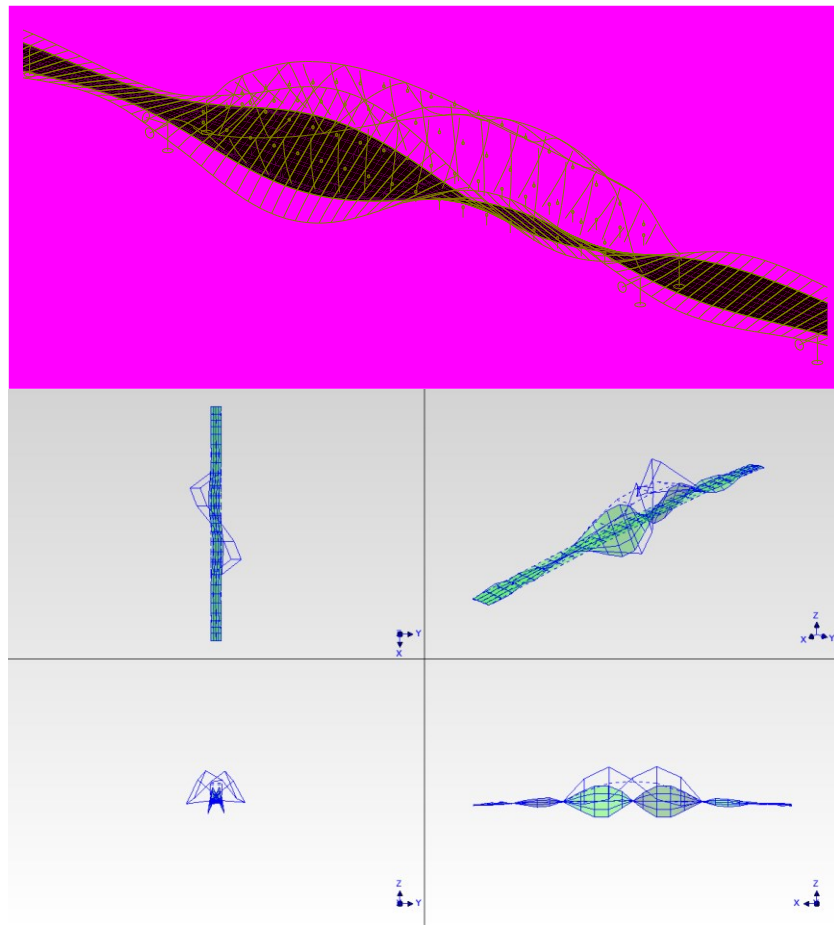
Figure 9. The visual comparison of the 4th theoretical natural mode (above) and 4th measured natural modes of vibration (below).

(for some examples, see figure 7, figure 8 and figure 9) were evaluated. They were compared with the appropriate theoretical natural frequencies (see table 1) and mode shapes (for two examples, see figure 7 and figure 9). As can be seen from table 1, a very good agreement between the measured and theoretical natural frequencies was achieved. It means, the theoretical model of the bridge was suitable enough.

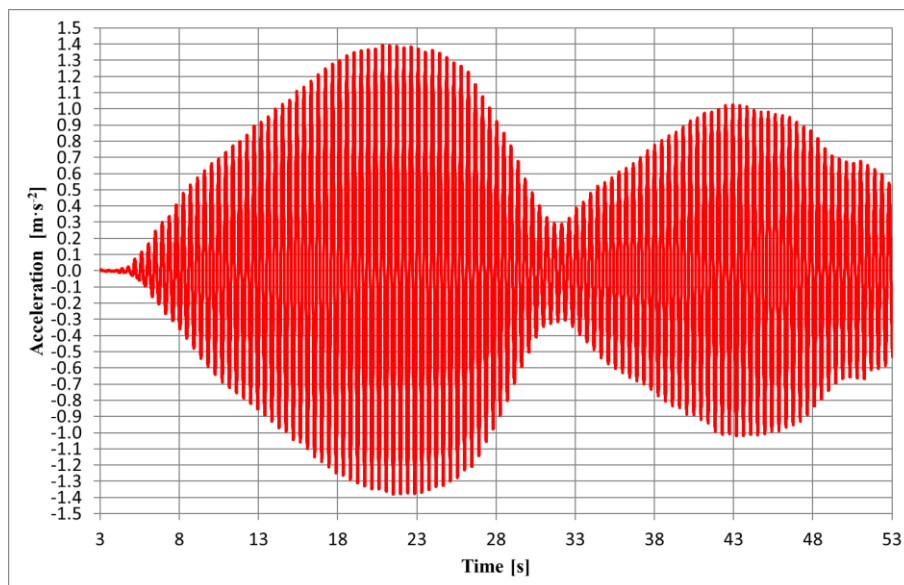
Figure 10. The record of the bridge vibration focused on vandalism at the natural frequency $f_{(3)} = 2.25$ Hz.

The load bearing structure of the observed bridge that is designed for standard road traffic is unusually sensitive to the dynamic effects of the pedestrians. In particular, the main span of the bridge can noticeably vibrate when the pace frequency of walking pedestrians is close to the third natural frequency. The dynamic effect of the group of nine vandals was verified in the course of the first stage of the experiment. The peak value of vertical acceleration achieved $1.39 \text{ m}\cdot\text{s}^{-2}$ (see figure 10). The

corresponding RMS value of acceleration was $0.97 \text{ m}\cdot\text{s}^{-2}$. The measured acceleration was double integrated in the time domain using Simpson's rule, then the peak value of evaluated vertical deflections achieved 7.1 mm and RMS value of deflection was 5.0 mm.

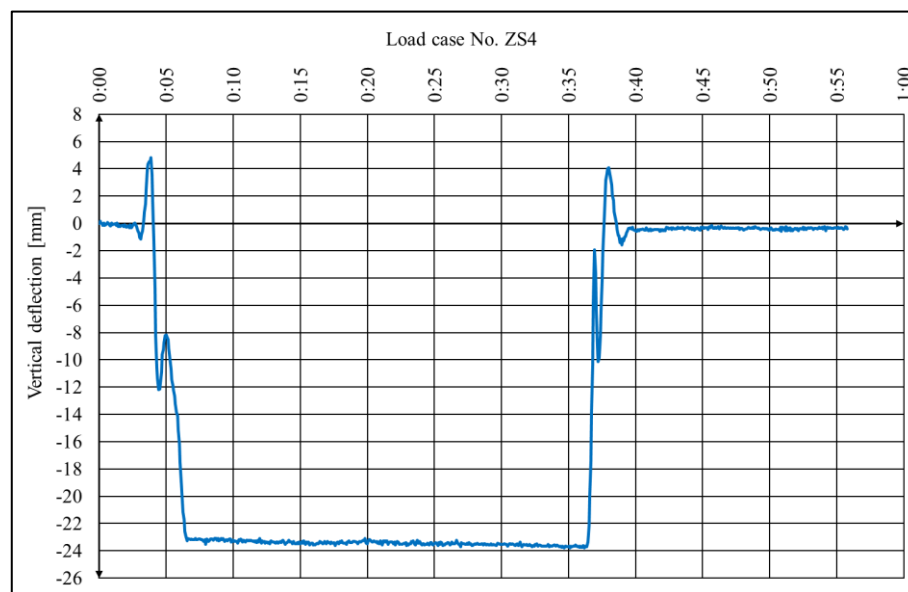
Figure 12. The time record of the vertical deflection of the right main girder in third quarter of the main bridge span.

The technique called Digital Image Correlation (DIC) was also applied during the first stage of the experiment but it was used in the course of the static load test only. Vertical deflection of the bridge main span in its third quarter that is drawn in figure 12 was measured by this technique. The obtained results were substantially more stable than ones measured using geodetic leveling and it was noticeable especially for the load case No. ZS4 (see figure 12).

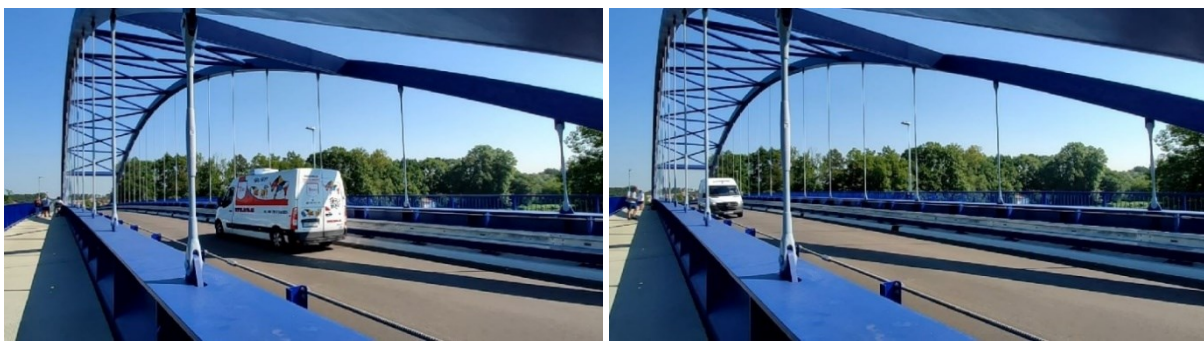
Figure 17. Passage of the vehicle in the direction from Mělice to Valy (left) and back (right).

Three cases occurring during the measurement were evaluated in more detail. The first case was the passage of a vehicle (a van) in the direction from Mělice to Valy (see figure 17). The second case was the passage of a vehicle (a van) in the opposite direction, i.e. from Valy to Mělice (see figure 17). The last case was the evaluation of the vibration of the bridge structure, which was caused by a group of several people walking at regular step.
